Summary of Second Jefferson Green - Assoc. ID # - 07501-14

This report is an update to an existing Reserve Study that was prepared for the association 7 years ago for the 2007 fiscal period. An observation of the property's common area elements took place on December 13, 2013 to verify the information from this previous report. In addition, we obtained information by contacting local vendors and contractors, as well as communicating with the property representative. To the best of our knowledge, the conclusions and suggestions of this report are considered reliable and accurate insofar as the information obtained from these sources.

Funding Summary For Second Jefferson Green

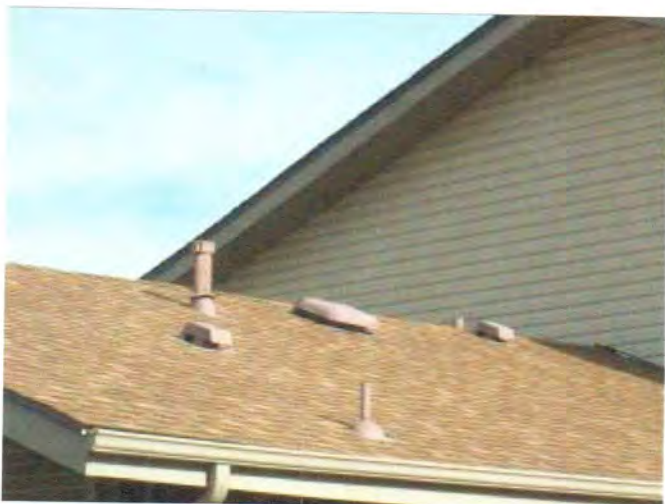
Comp #: 105 Comp Shingle Roof - Replace (1)

Installed shingles appear to be a "30" year rated shingle and are in good condition at time of observation with only minor surface granule loss (typical). Despite the 30 year rating, associations should expect to replace comp shingles on a 20 year cycle due to small hail events, freeze/thaw cycles, and high winds. Estimates on this line item are for complete tear off and replacement.

\$300/square; Estimate to remove and replace

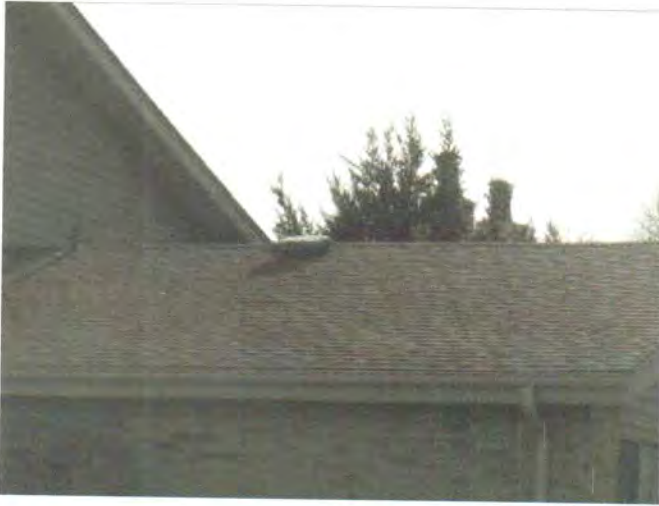
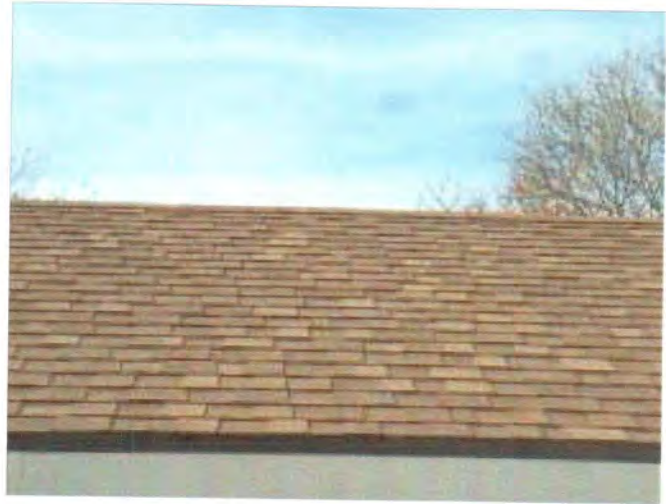
Comp #: 106 Comp Shingle Roof - Replace (2)

Installed shingles appear to be a "30" year rated shingle and are in fair condition at time of observation with surface granule loss and minor curling noted. Despite the 30 year rating, associations should expect to replace comp shingles on a 20 year cycle due to small hail events, freeze/thaw cycles, and high winds. Estimates on this line item are for complete tear off and replacement.

\$300/square; Estimate to remove and replace

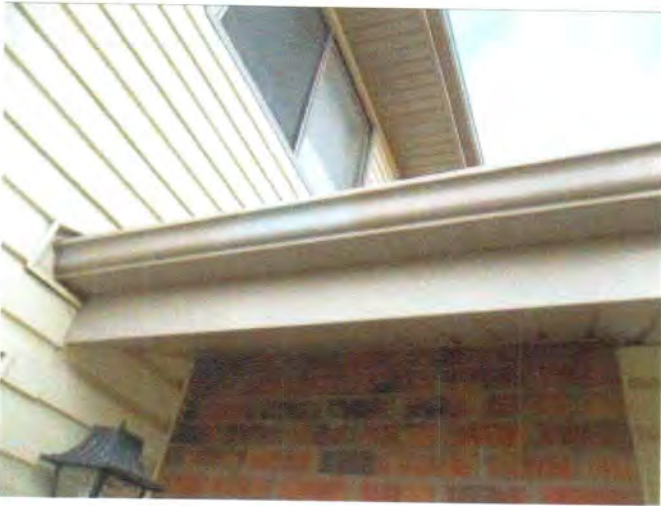
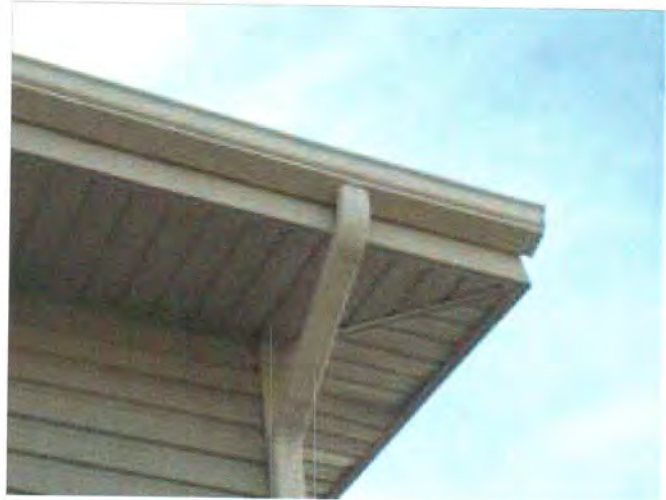
Comp #: 120 Gutters/Downspouts - Replace (1)

Gutters and downspouts appeared to be properly sloped and no overtly damaged gutter lines or downspouts were noted. Expect to replace the gutters and downspouts at the same time as replacing the comp shingle roofs every 20 years. At time of preparing this report, it was not clear whether the gutters and downspouts were replaced at time of the last roof replacement cycle. However, for best cost estimates, we recommend replacing all lines within the next 12 - 15 years and at the same time as roof replacement.

\$5.25/LF; Estimate to replace

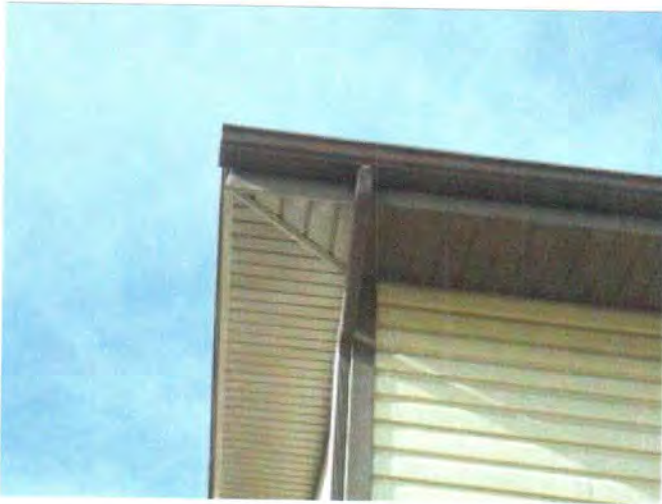
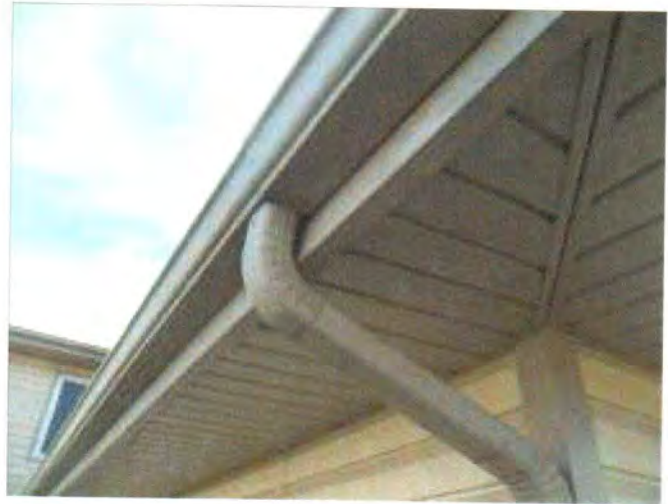
Comp #: 121 Gutters/Downspouts - Replace (2)

Gutters and downspouts appeared to be properly sloped and no overtly damaged gutter lines or downspouts were noted. Expect to replace the gutters and downspouts at the same time as replacing the comp shingle roofs every 20 years. At time of preparing this report, it was not clear whether the gutters and downspouts were replaced at time of the last roof replacement cycle. However, for best cost estimates, we recommend replacing all lines within the next 7 - 8 years and at the same time as roof replacement.

\$5.25/LF; Estimate to replace

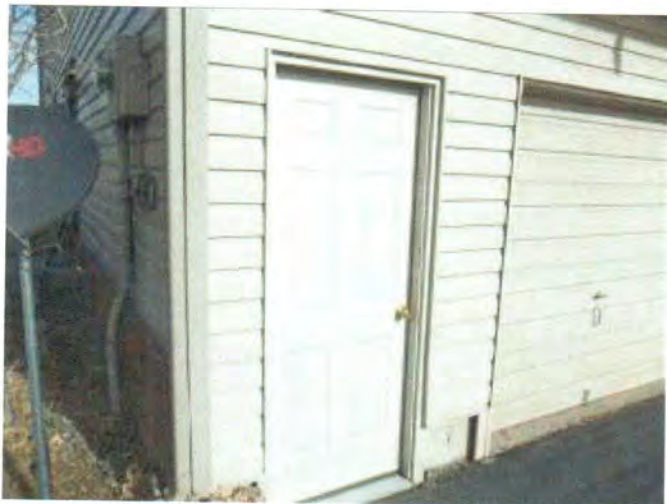
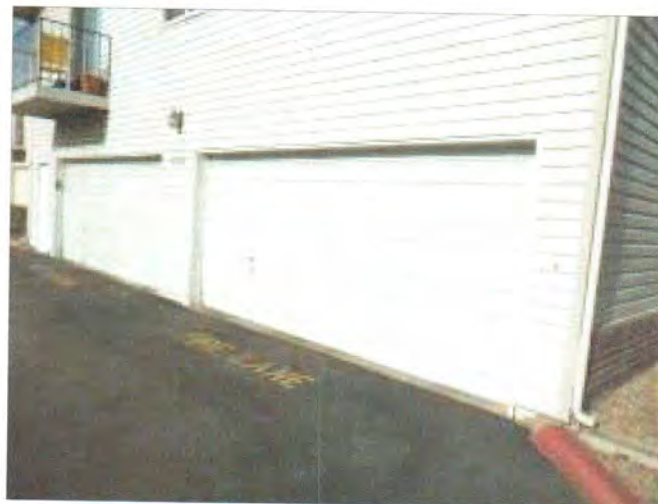
Comp #: 202 Garage Door Trim/Access Doors - Repaint

Many areas of missing paint were noted, especially on the garage door trim and most affected areas were at or near grade. The advanced deterioration at the bottom of the trim is likely due to frequent contact with water and ice on the asphalt. Expect to repaint doors and door trim every 4 - 5 years.

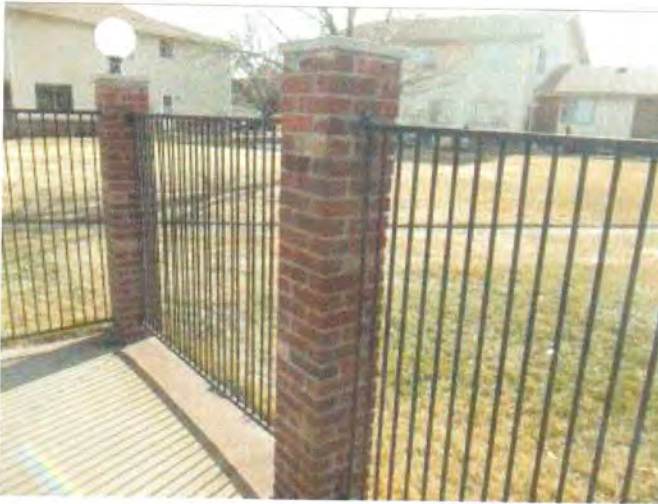
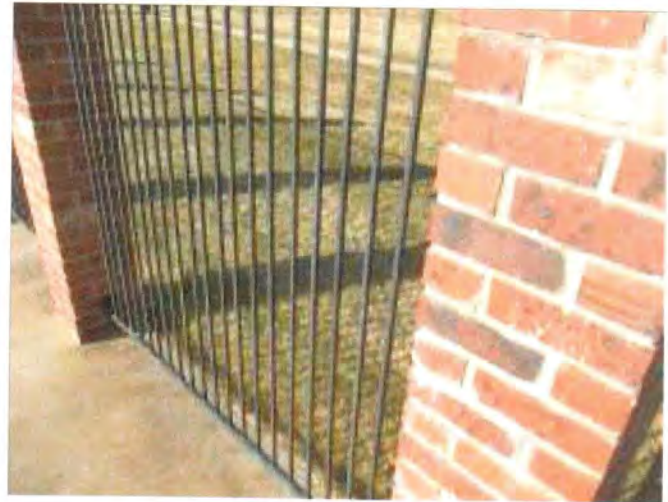
Comp #: 207 Iron Fencing - Repaint

Paint on exterior metal surfaces are faded and thinning throughout the community and painting should be completed within this calendar year (2014). Under normal conditions and with proper maintenance, metal should be painted every 3 - 4 years to ensure an appropriate appearance and to protect the materials from the elements. Make any needed repairs at the same time as repainting using operating funds.

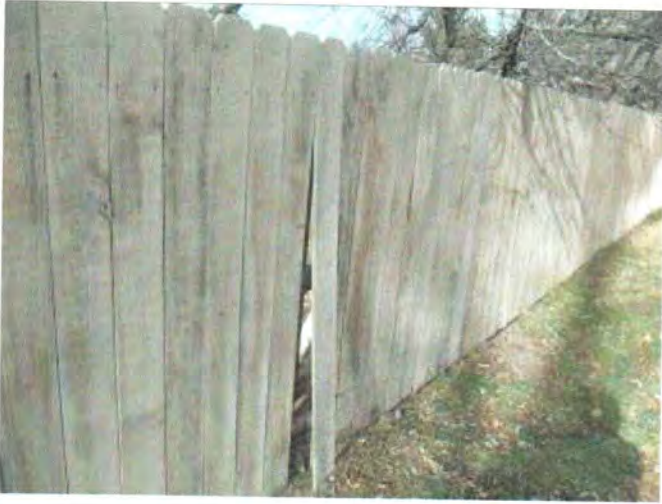
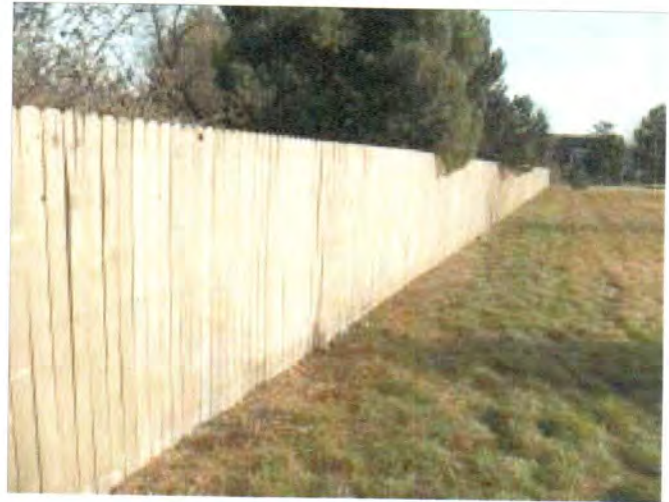
Comp #: 209 Wood Fencing - Stain

Fence stain is thin and many areas of exposed wood were present at the bottom of the slats. Restain the wood fencing throughout the community this fiscal year (2014) to prevent advanced deterioration of the fence. Wood fencing should be stained every 2 - 3 years in this climate.

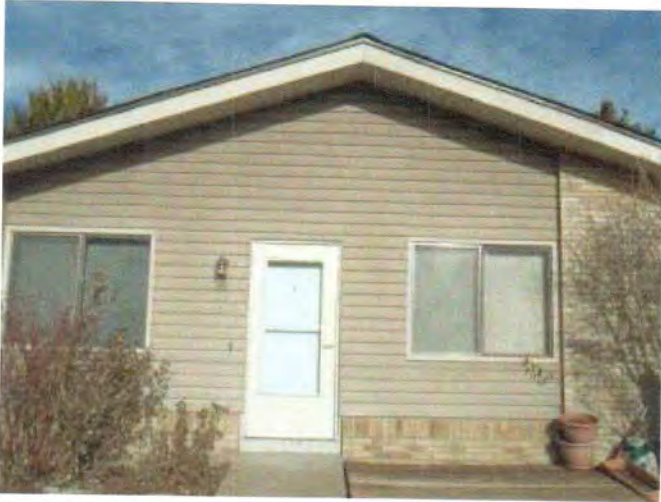
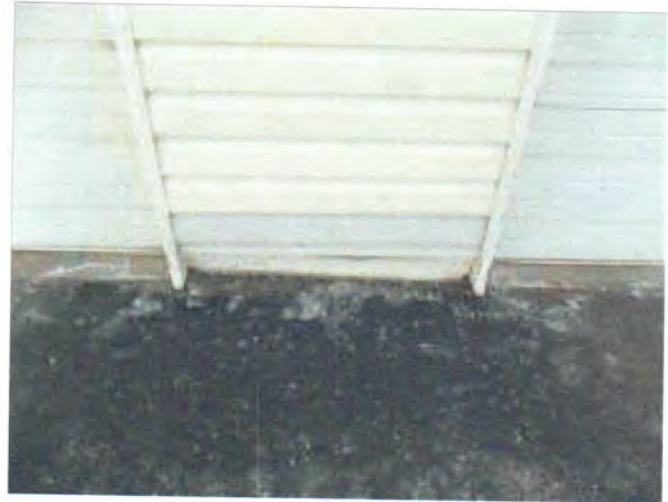
Comp #: 302 Vinyl Siding - Replace (1)

At time of observation it appeared that areas of vinyl siding are being replaced with new siding. The problem with the current process for vinyl siding replacement is that the colors do not match, the style is different and the overall appearance of the buildings is affected. The most apparent siding issues are on the South facing exterior walls where the siding has severely faded. The typical useful life of vinyl siding is 20 - 25 years in this environment and complete replacement should be planned within the next 9 - 11 years. We have split siding replacement into 3 phases in an attempt of ease budgeting concerns.

\$6.00/GSF; Estimate to replace

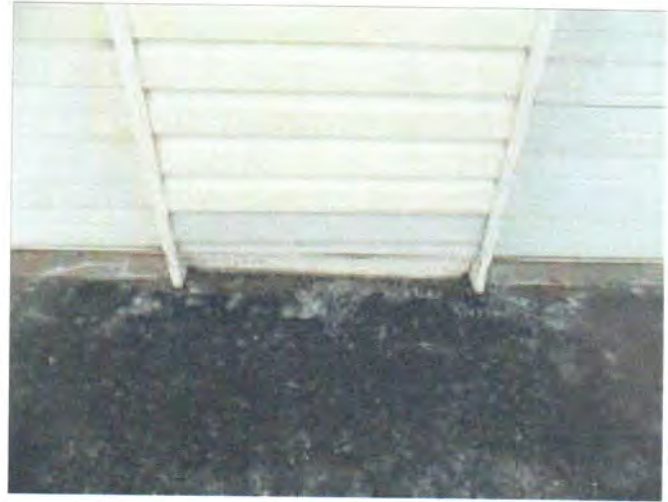
Comp #: 303 Vinyl Siding - Replace (2)

At time of observation it appeared that areas of vinyl siding are being replaced with new siding. The problem with the current process for vinyl siding replacement is that the colors do not match, the style is different and the overall appearance of the buildings is affected. The most apparent siding issues are on the South facing exterior walls where the siding has severely faded. The typical useful life of vinyl siding is 20 - 25 years in this environment and complete replacement should be planned within the next 9 - 11 years. We have split siding replacement into 3 phases in an attempt of ease budgeting concerns.

\$6.00/GSF; Estimate to replace

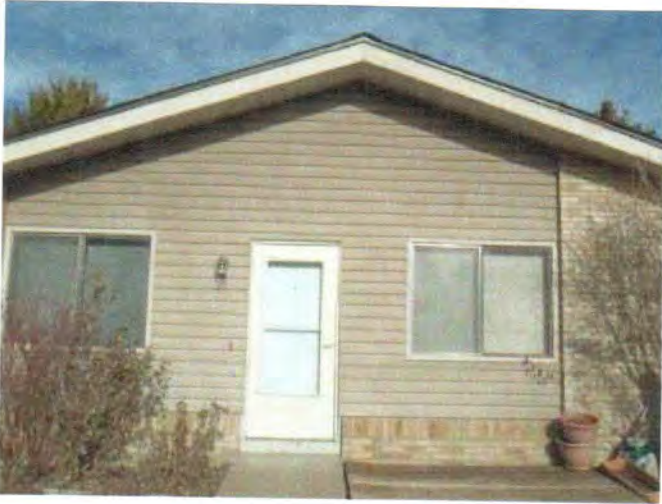
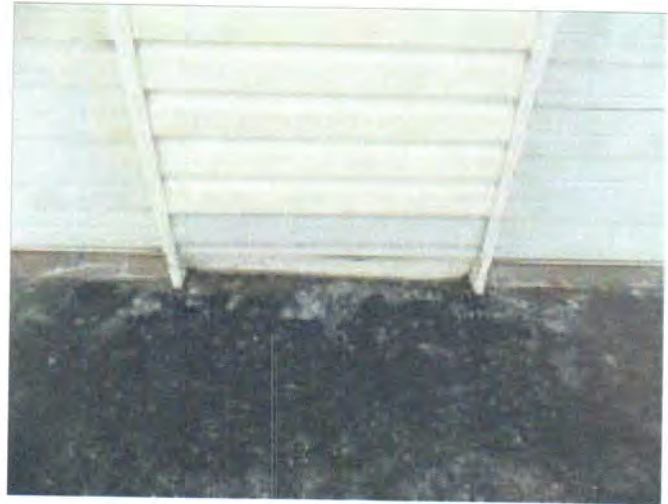
Comp #: 304 Vinyl Siding - Replace (3)

At time of observation it appeared that areas of vinyl siding are being replaced with new siding. The problem with the current process for vinyl siding replacement is that the colors do not match, the style is different and the overall appearance of the buildings is affected. The most apparent siding issues are on the South facing exterior walls where the siding has severely faded. The typical useful life of vinyl siding is 20 - 25 years in this environment and complete replacement should be planned within the next 9 - 11 years. We have split siding replacement into 3 phases in an attempt to ease budgeting concerns.

\$6.00/GSF; Estimate to replace

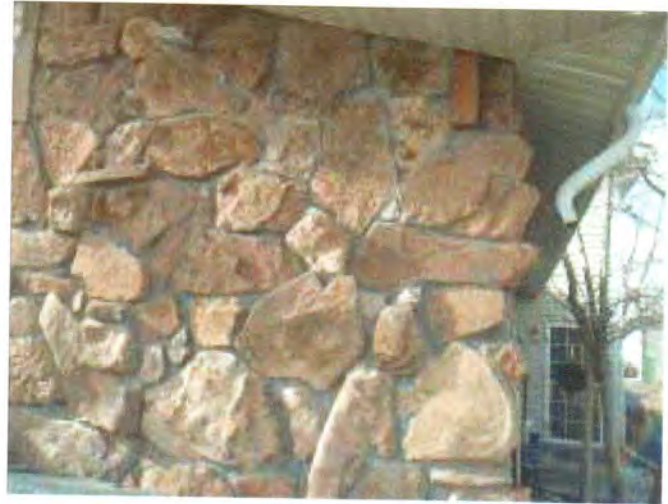
Comp #: 306 Brick/Flagstone - Replace

Stones and bricks appeared to be adhered to the sides well with no loose or missing material noted. Typically, this type of material has an extended life expectancy and complete replacement is unlikely. There are times where some stones will loosen and fall off, but this is unpredictable when and how much would occur. Repairs should be handled as a maintenance issue on an as needed basis. Therefore, Reserve funding is not required for this component at this time. If it later turns out that frequent repairs are necessary, then funding could be added in future Reserve Study updates.

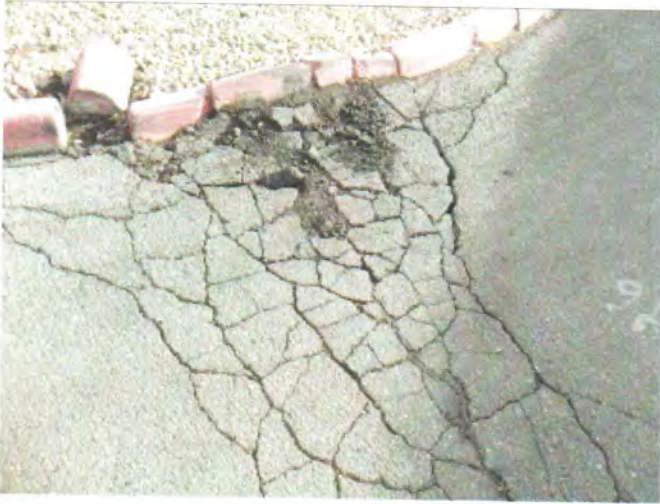
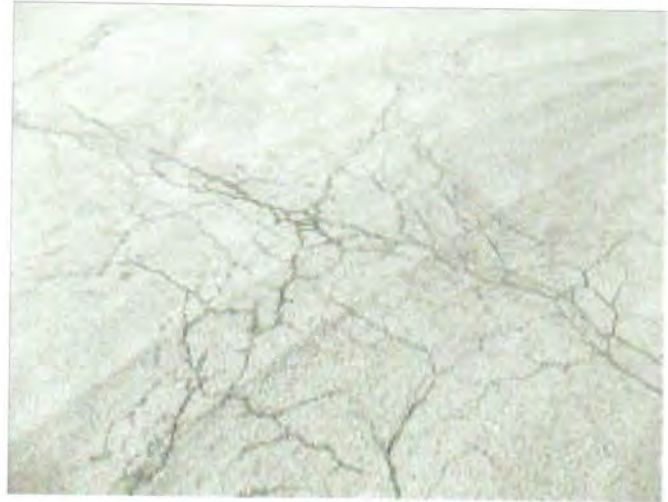
Comp #: 401 Asphalt - Overlay

Asphalt surfaces are starting to deteriorate exponentially as compared to the conditions last observed in 2007. There were many areas of IR patching noted and still other areas that show signs of settling, ponding and severe "alligatoring". The asphalt in the community should be roto-milled and overlayed within the next 2 - 3 years to restore appearance and function. An overlay should be planned every 20 - 25 years in this environment depending on levels of maintenance and care.

\$3.00/GSF; Higher estimate for more repairs

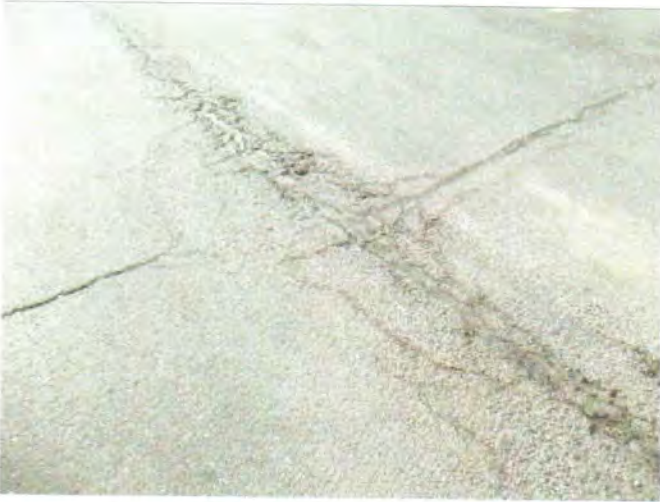
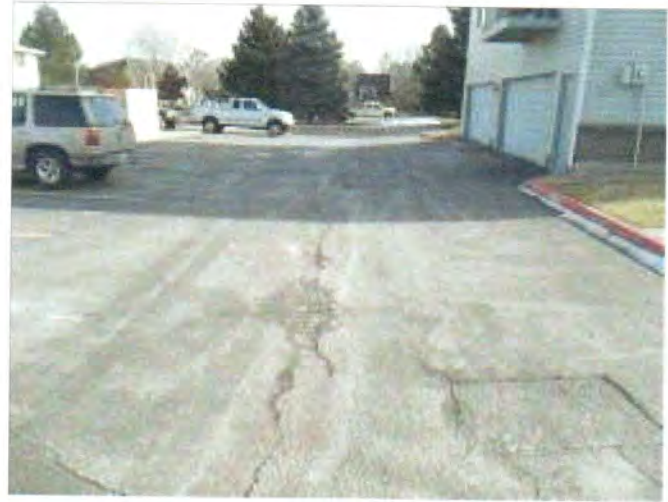
Comp #: 402 Asphalt - Seal Coat/crack fill

Seal coat should be planned every 3 - 4 years in this environment to protect against oxidation and water damage. It is generally recommended that asphalt seal coating occur in the Spring season. Crack seal and joint seal should occur annually on an as needed basis using operating funds.

\$.18/GSF; Higher est. includes repairs/crack fill

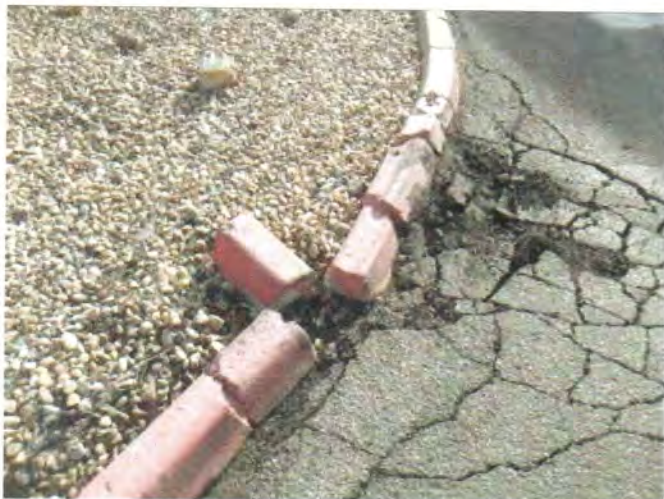
Comp #: 407 Drive Concrete - Replace

In general, concrete curbs and gutters are in poor condition with cracking and chipped surfaces throughout community. Many sections are either cracked or completely breaking apart. Curbs and gutters are subject to more advanced deterioration due to trucks and plows hitting them during the year. Since we are recommending that the association complete a full mill and overlay in approximately 3 years, we recommend replacing the curbing and drain pans at the same time in order to receive the best possible cost estimate based on quantity of work. If the work is completed upon updating this report, we can adjust this line item to reflect a periodical allowance in the future for concrete repairs rather than complete replacement.

Estimate to replace drive concrete

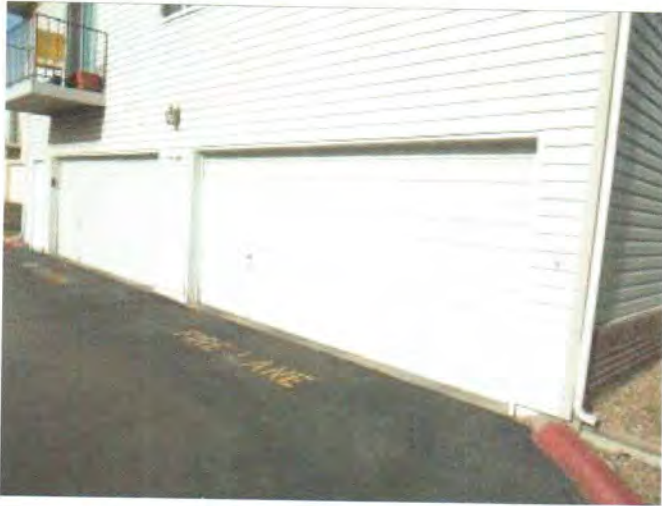
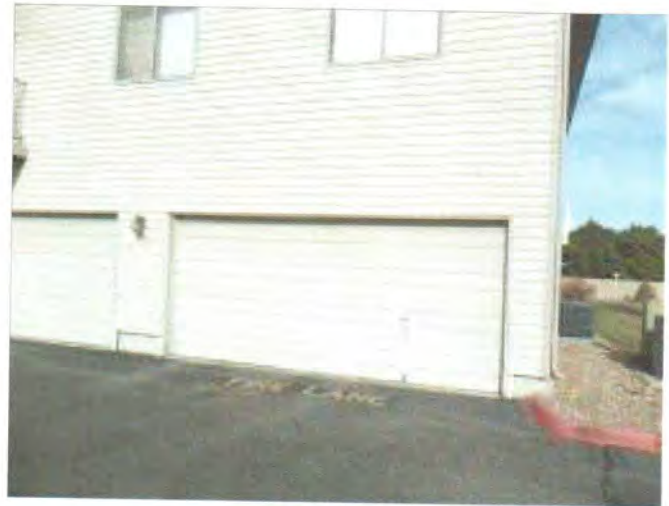
Comp #: 502 Garage Doors - Replace

Conditions vary throughout the community with several doors showing signs of wear and deterioration with numerous dings and dents. The declarations specifically state the association is responsible for replacement. We suggest establishing a Reserve fund for replacement so the association can maintain a consistent appearance and obtain the best replacement cost possible due to replacing multiple doors at the same time. The average life expectancy for these types of garage doors should range between 20 - 25 years with proper use and care.

\$850/door; Estimate to replace doors

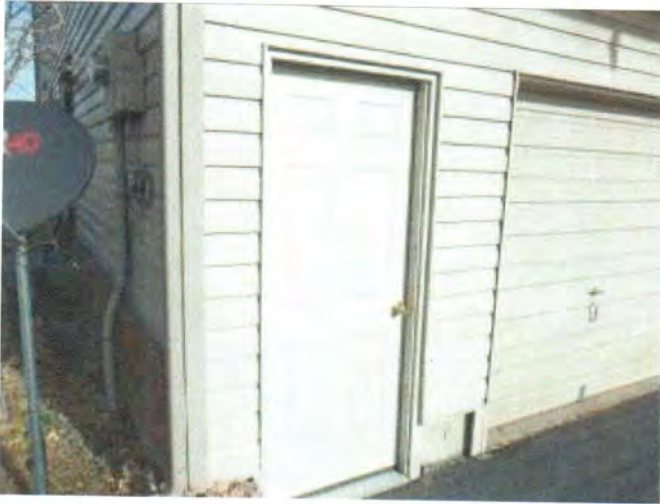
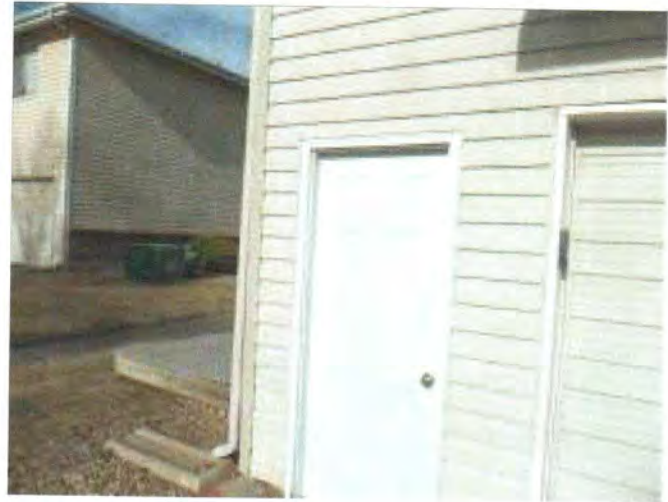
Comp #: 503 Garage Access Doors - Replace

It appears that several doors have been replaced since our last site visit in 2007 and the replacement plan of 10 doors every 5 years is keeping the association doors appearing in good to fair condition. No overtly damaged doors were observed. Continue to fund partial door replacement on a 5 years cycle to maintain appearance and function.

Estimate to replace 10 doors every 5 years

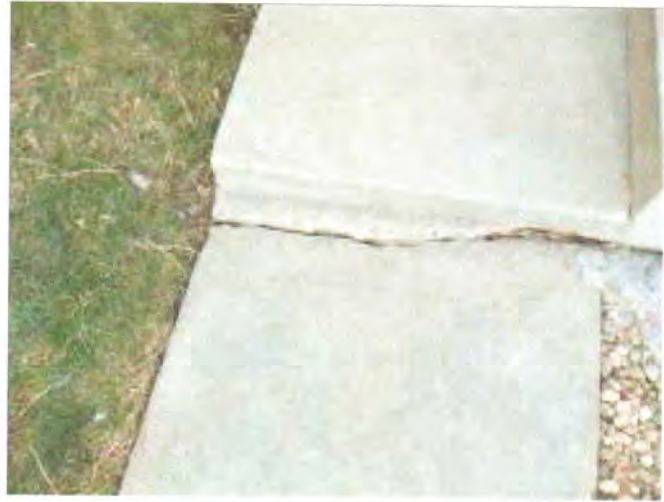
Comp #: 601 Concrete Sidewalks/Decks - Repair

It is unlikely that all concrete surfaces will fail and need to be replaced at the same time. Based on our recent property observation, the sidewalk concrete conditions are worsening and therefore we are recommending a more aggressive plan for repairs/replacement. Frequent repairs and replacement to a percentage of the area (10% or 4200 GSF), should be anticipated every 4 years.

Estimate to replace 5% of area every 3 years

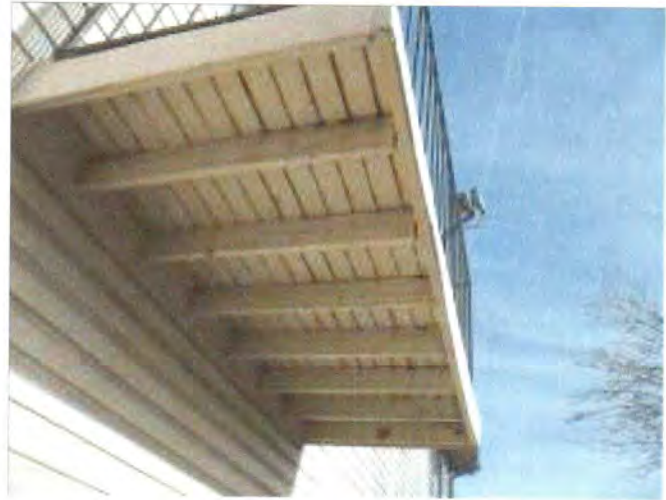
Comp #: 607 Wood Deck - Replace

Some units had front decks, but they varied in design, size, and type of material from unit to unit. Assume these front decks are the responsibility of the individual unit owner. Therefore, Reserve funding is not required for the front decks. The upper unit decks are considered to be exclusive use common areas and should be the responsibility of the owner that has access to the decks. However, it was reported the decks are the responsibility of the association. Due to varying conditions and levels of use, we recommend replacing approximately 10 decks every 4 years. When replacement is required, we recommend using an alternative product (composite decking) that has a longer life expectancy and requires less maintenance.

Estimate to replace 10 decks every 4 years

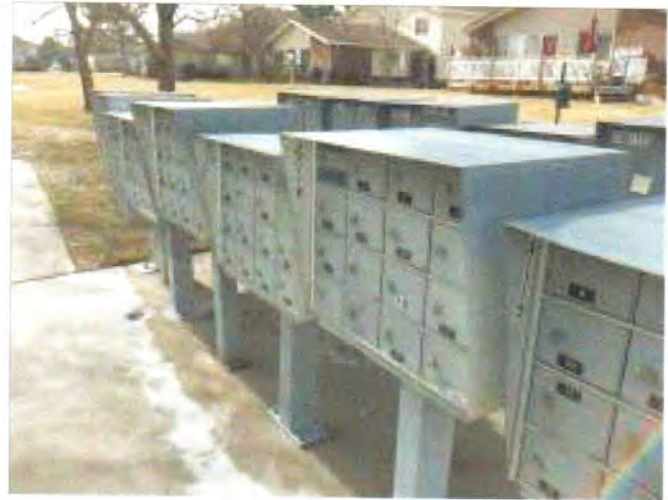
Comp #: 803 Mailboxes - Replace

Mailbox stations are rusting at the base where they are anchored into the concrete pad. According to several manufacturers, the typical life expectancy for this type of mailbox is 12 - 18 years in this environment. Remaining life is based on average age of all units. While it is possible the US Post Office will maintain and replace these boxes in the future, in our experience, we have seen in numerous similar circumstances that the post office makes the association responsible for replacement. This line item is included as a conservative measure in case the post office decides the association is responsible for replacement.

\$1650/CBU; Estimate to replace

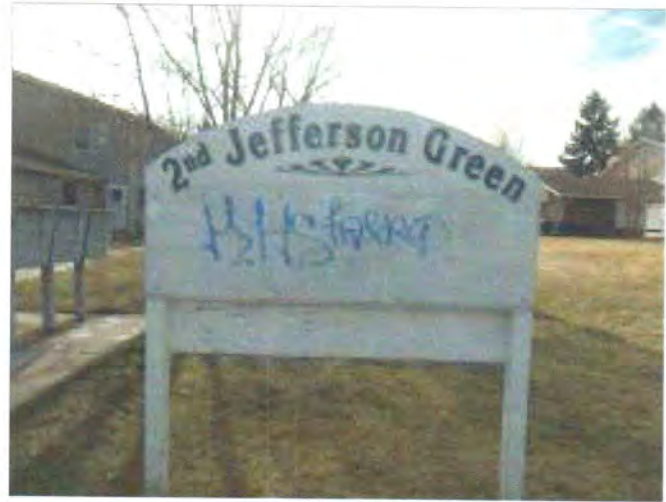
Comp #: 809 Address Signs - Replace

Noted several areas of missing paint and some of the plywood chipping off on at least one sign. Another sign had been vandalized. It is typical for similar communities in the area to replace address signs every 10 - 12 years in order to ensure legibility and a modern and appropriate appearance to the community entrances. Expect to replace these signs during this fiscal year (2012) to restore/modernize the appearance.

\$375/sign; Estimate to replace with similar

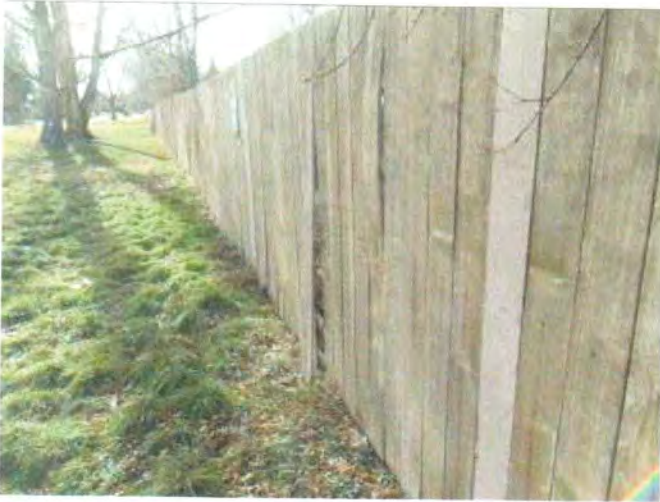
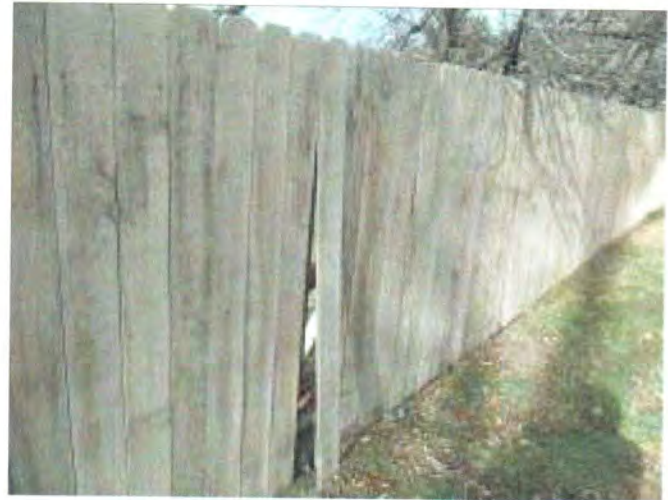
Comp #: 1001 Wood Fencing - Replace (1)

Noted several slats that had come loose from the bottom rail but no broken slats in this particular area of the fence line. Expect to completely replace this section of fence within the next 8 - 10 years depending on diligence in staining and general maintenance levels.

\$22/LF; Estimate to replace

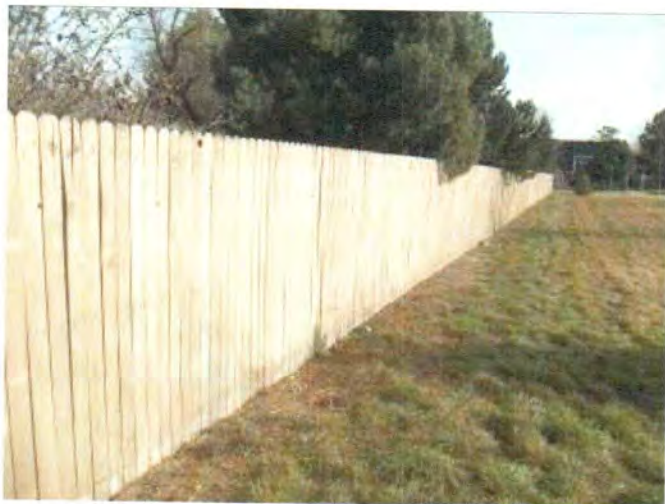
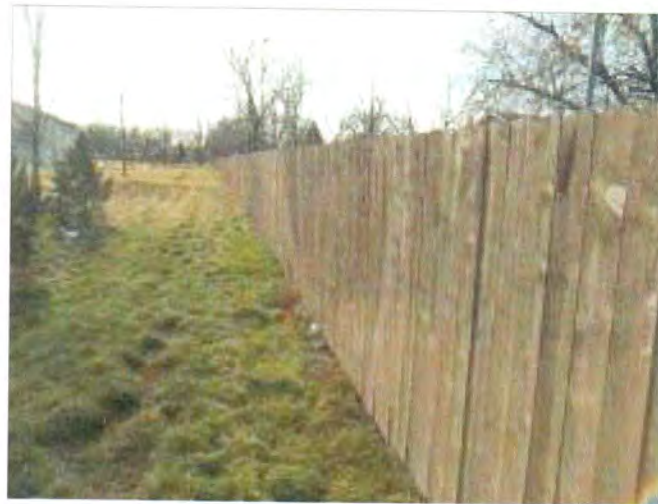
Comp #: 1001 Wood Fencing - Replace (2)

This fence appeared in good condition with a few replacement slats noted and some minor warping apparent. Expect a useful life of approximately 20 years from this fence if properly maintained and stained frequently and regularly.

\$22/LF; Estimate to replace

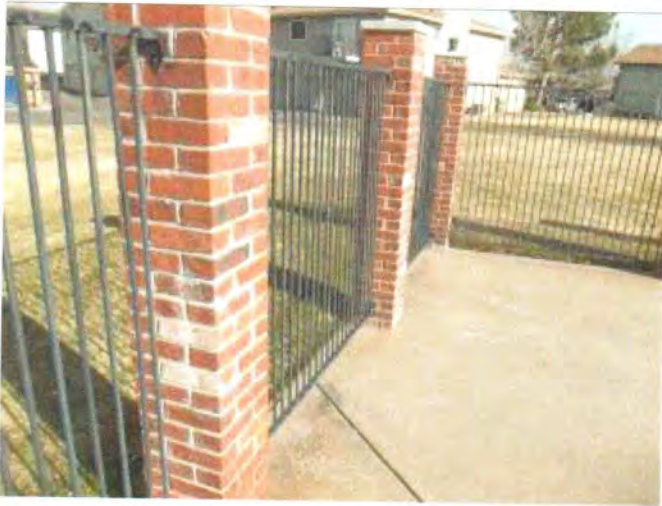
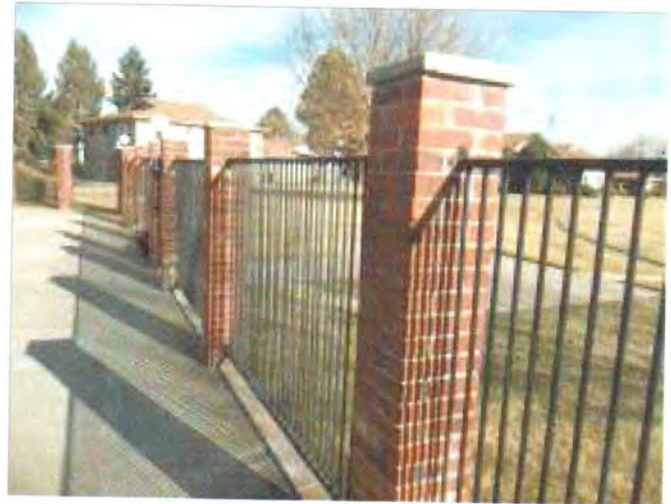
Comp #: 1002 Ironwork Fencing - Replace

Iron fencing appeared in fair condition at time of observation with some bent areas noted as well as some superficial rust along the bottom rail. Expect to replace this fencing within the next 10 - 12 years if properly maintained. The fence does not appear to have been replaced since our last site visit, but significant repairs were made to extend the useful life. If the fence is painted frequently and minor repairs are made cyclically, expect this fence to have a remaining life of approximately 12 years.

\$35/LF; Estimate to replace

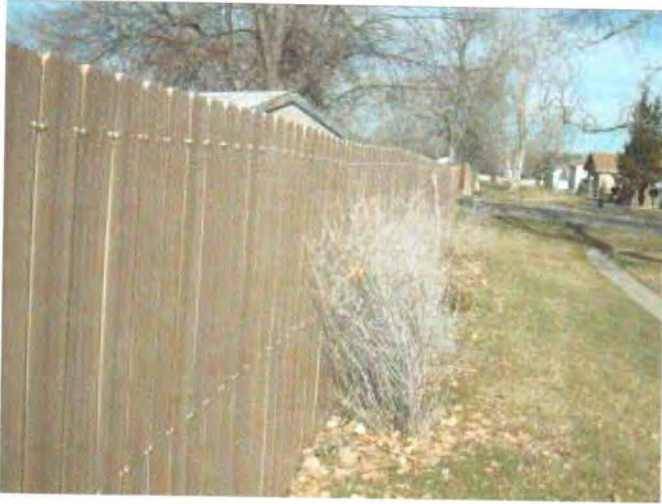
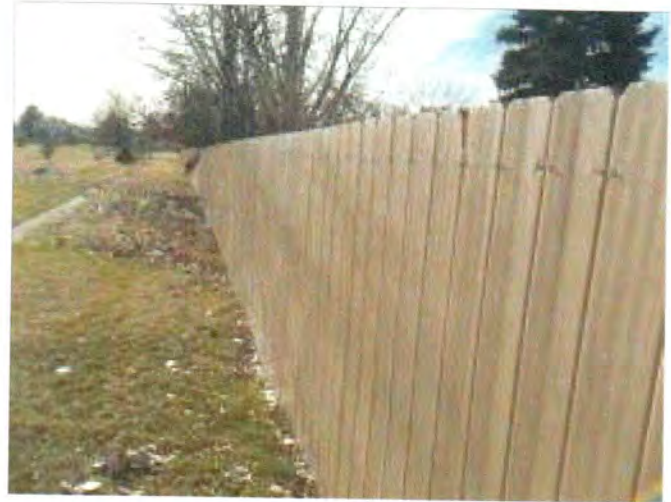
Comp #: 1008 Vinyl Fencing - Replace

Vinyl fencing is performing as expected and appeared in good to fair condition at time of observation with no broken or otherwise damaged slats or rails. Expect the vinyl fencing to have a typical useful life of 30 years if properly maintained.

\$45/LF: Estimate to replace (privacy)

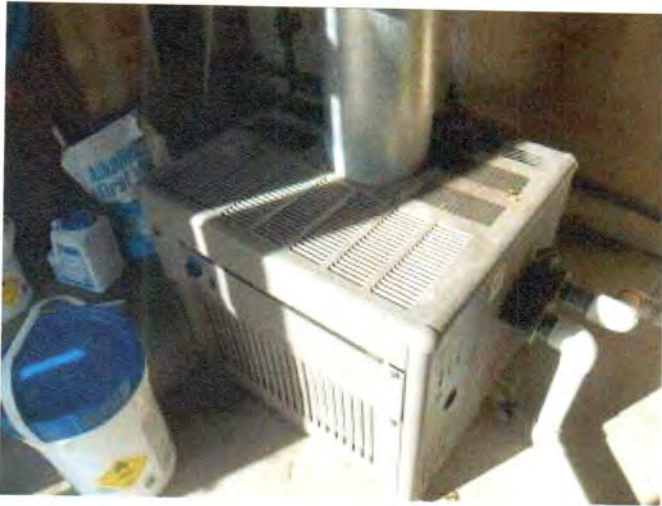
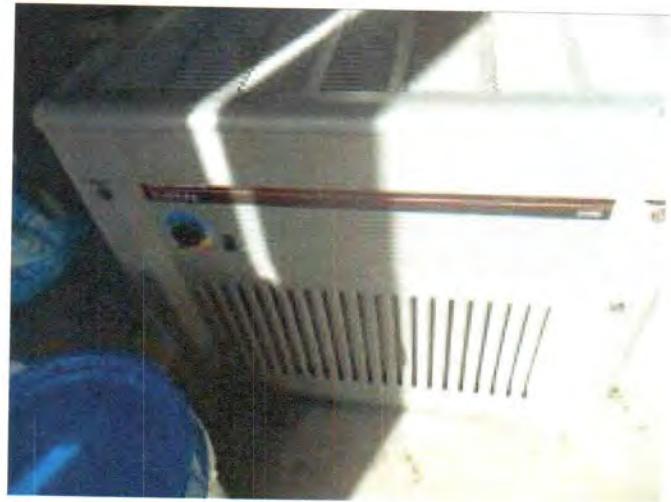
Comp #: 1104 Pool Heater - Replace

Pool heater is nearing the end of its typical useful life and replacement should be planned within the next year. This type of pool heater typically has a useful life of approximately 10 to 12 years, depending on the level of maintenance and the quality of water running through the system. Remaining life based on current age and condition of the exterior of the unit.

Estimate to replace with similar type heater

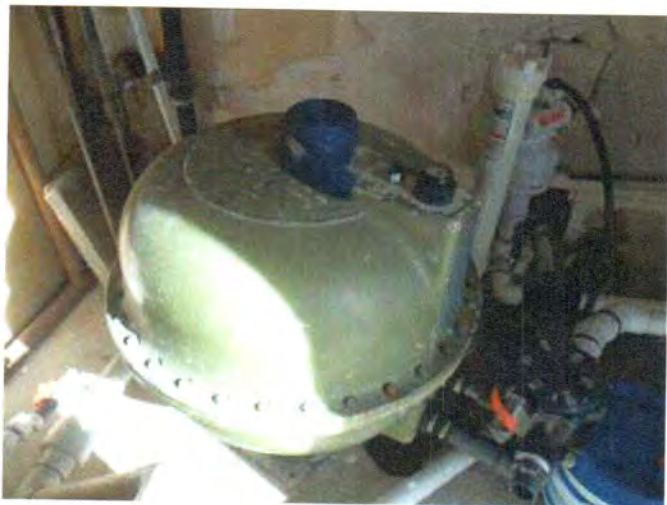
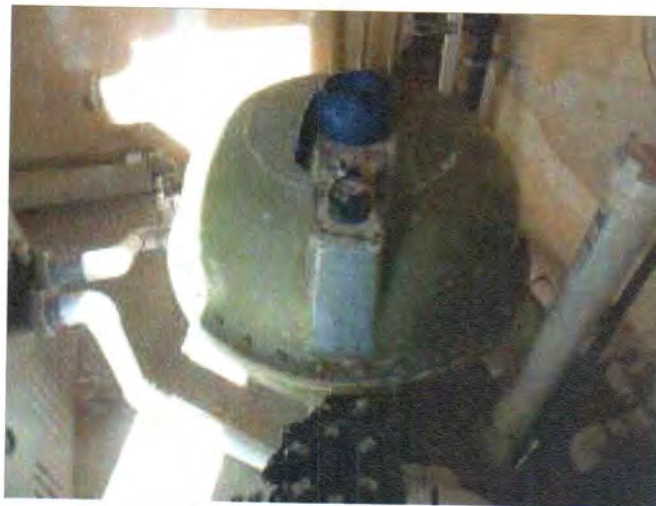
Comp #: 1107 Pool Filter - Replace

Filter is cast iron and there were no reports of problems at time of observation. Expect to replace this filter within the next 5 - 6 years depending on levels of maintenance and the quality of water running through the system. Most new filters are plastic or fiberglass and the typical useful life for new filters is 12 - 15 years under normal conditions.

\$1700/filter; Estimate to replace with similar size

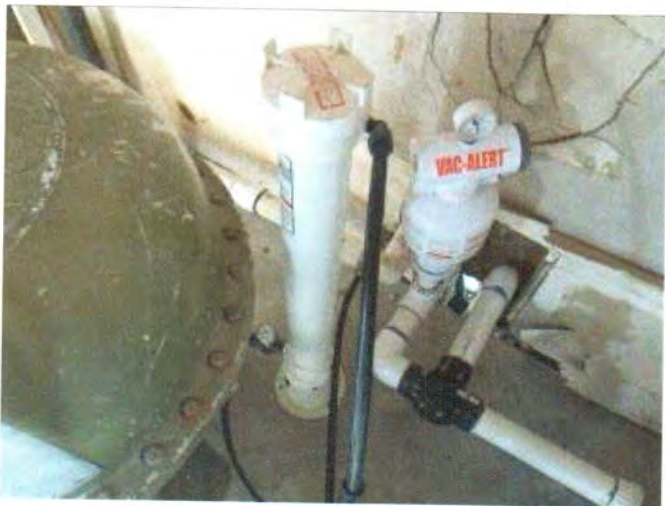
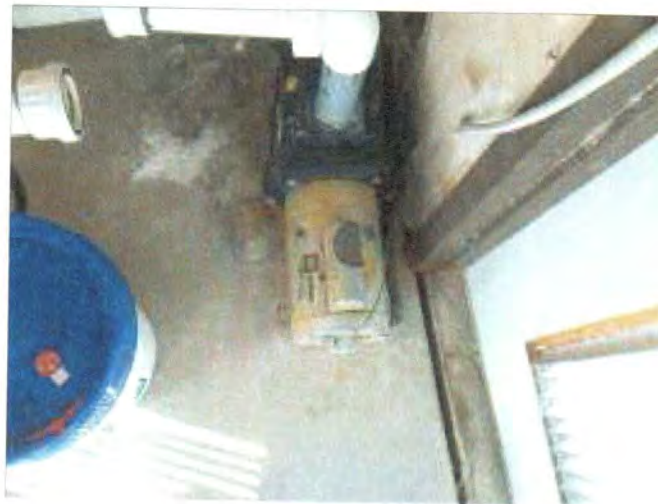
Comp #: 1111 Misc. Pool Equipment - Replace

No unusual conditions were observed or reported at time of report preparation. The individual replacement costs of these items is too small for separate Reserve designation. Therefore, we suggest the association replace these items on an as needed basis with general operating/maintenance funds.

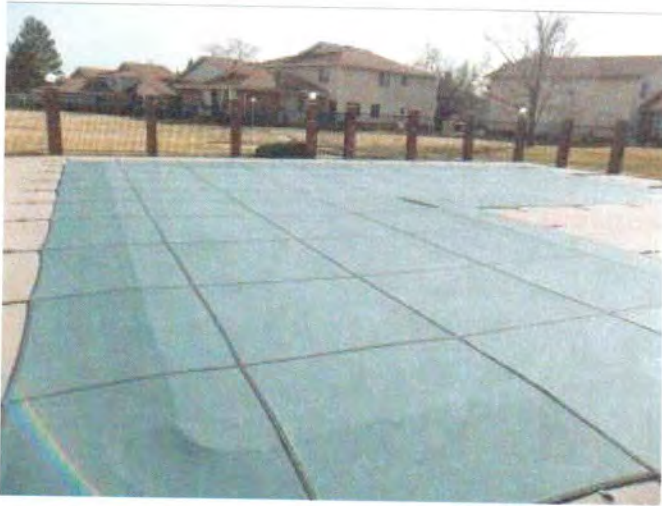
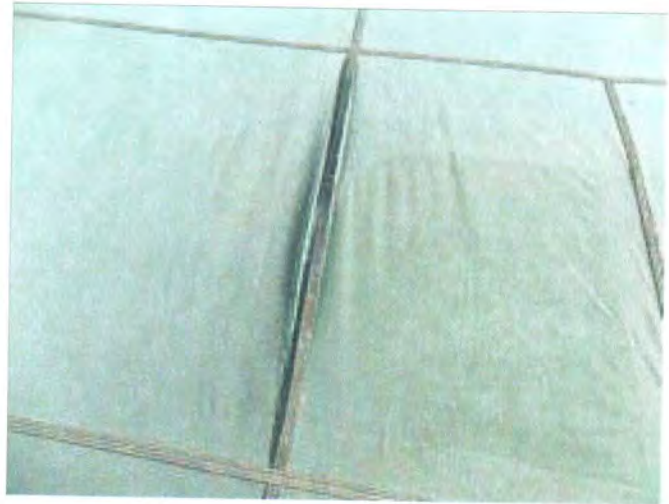
Comp #: 1112 Pool Cover - Replace

Overall, the pool cover appeared in fair condition with only one area that should be repaired at the time of removal/storage in the Spring. The typical useful life of covers ranges between 10 and 12 years when stored according to manufacturers specifications and with proper maintenance.

\$2.25/GSF; Estimate to replace

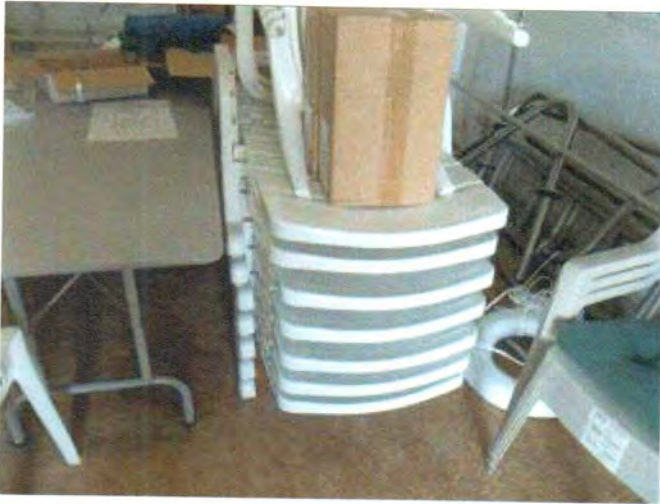
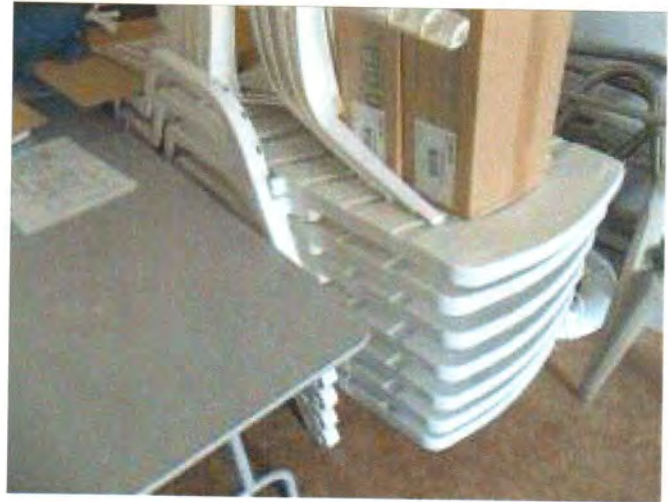
Comp #: 1120 Pool Furniture - Replace

Furniture is older and in poor condition. Majority of pieces are plastic and have a very low replacement cost. Due to the overall quantity and the low cost, we suggest replacing these on an as needed basis with general operating funds. Therefore, at this time, Reserve funding is not required for this component.

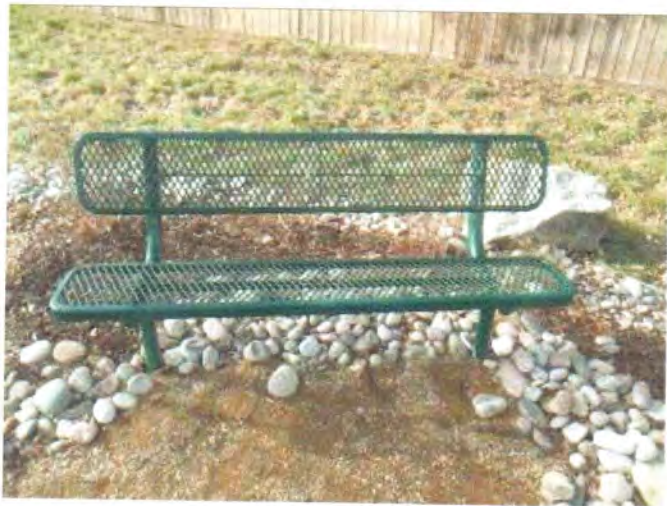
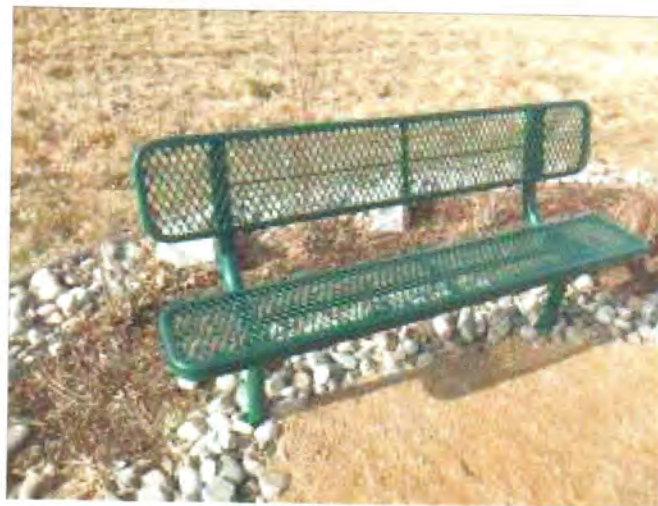
Comp #: 1307 Benches - Replace

Benches are relatively new and in good condition at time of observation. The typical life expectancy for this type of bench is 10 - 12 years if properly maintained. It is paramount to make sure that this type of bench is not in direct contact with irrigation spray as it will severely shorten the useful life of the plasticized coating; shortening the useful life of the bench. Keep the posts painted to prevent rust and corrosion.

\$1,100/bench; Estimate to replace

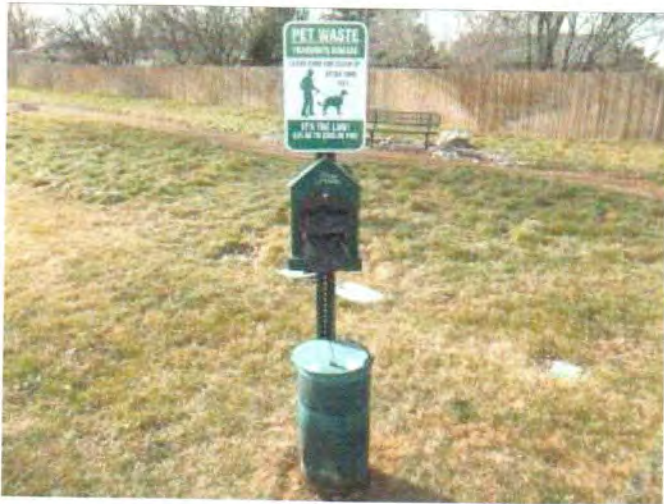
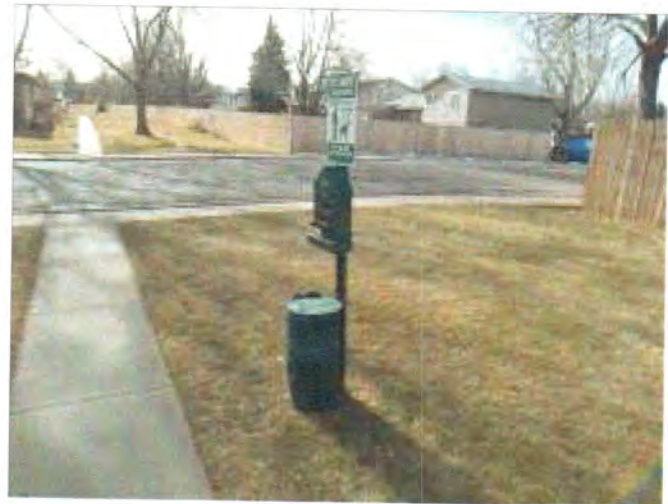
Comp #: 1311 Pet Waste Pick Up Stations - Replace

Due to the unlikely event that all stations will fail and need to be replaced at the same time and the low cost of individual replacement, we do not recommend reserving to replace stations at this time. Replace individually on an as needed basis using operating funds. No reserve funding necessary for this component at this time.
