Summary of Second Jefferson Green - Assoc. ID # - 07501-14

This report is an update to an existing Reserve Study that was prepared for the association 7 years ago for the 2007 fiscal period. An observation of the property's common area elements took place on December 13, 2013 to verify the information from this previous report. In addition, we obtained information by contacting local vendors and contractors, as well as communicating with the property representative. To the best of our knowledge, the conclusions and suggestions of this report are considered reliable and accurate insofar as the information obtained from these sources.

Funding Summary For Second Jefferson Green

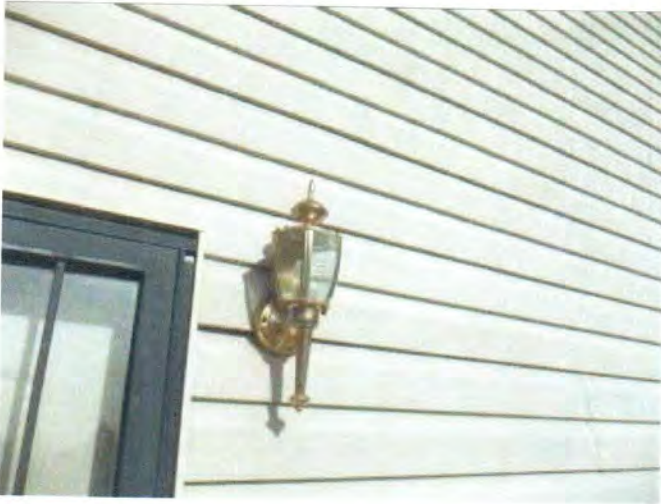
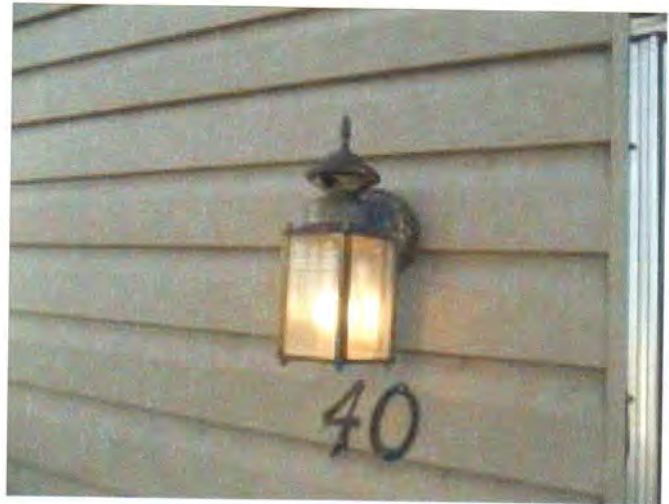
Comp #: 1602 Exterior Wall Mount - Replace

Wall lights are aged in appearance and replacement should be planned within this fiscal year to restore a modern appearance to the building exteriors. While fixtures can be replaced on an as needed basis using operating funds, we recommend replacing all fixtures at the same time in order to receive the best possible cost estimate based on quantity of work and to ensure a consistent appearance throughout the community.

\$100/light; Estimate to replace

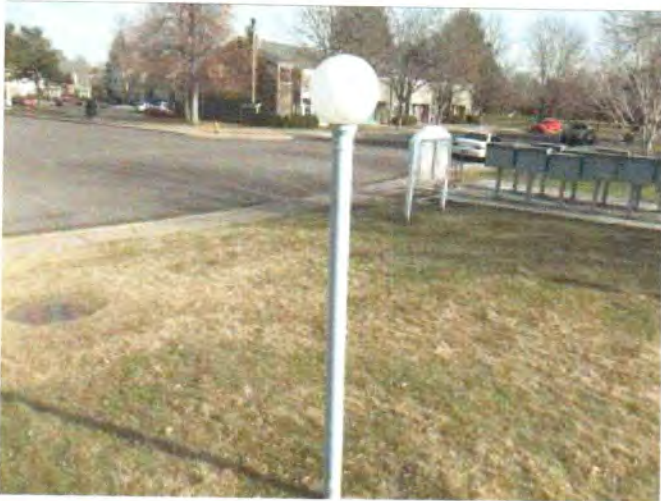
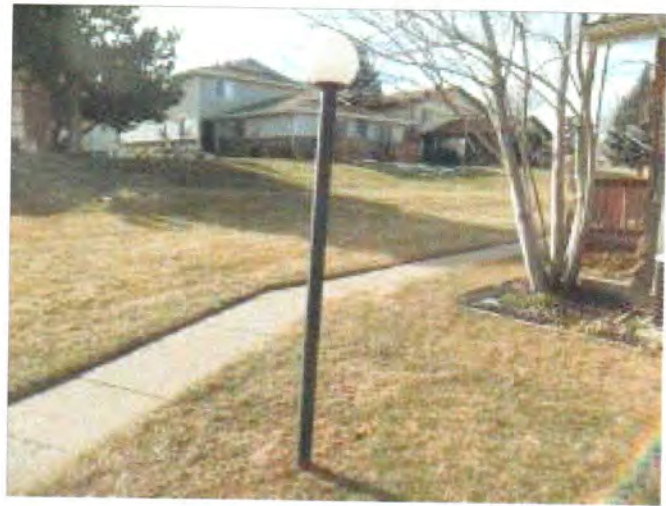
Comp #: 1604 Pole Lights - Replace

Poles have been painted within the last 4 - 5 years but majority have faded and paint is peeling and metal is exposed. In order to restore appearances, we recommend replacing the poles and fixtures to restore appearances throughout the community. Expect to replace pole lights every 18 - 20 years. Replace all fixtures at the same time to ensure a consistent appearance and in order to receive the best possible cost estimates based on quantity of work.

\$250/fixture; Estimate to replace with similar

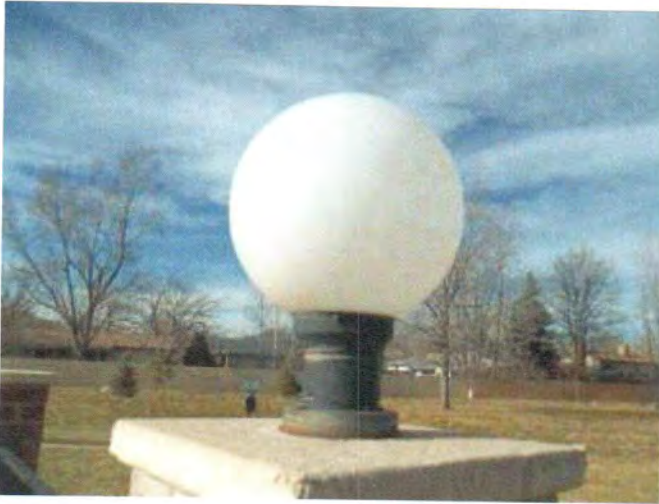
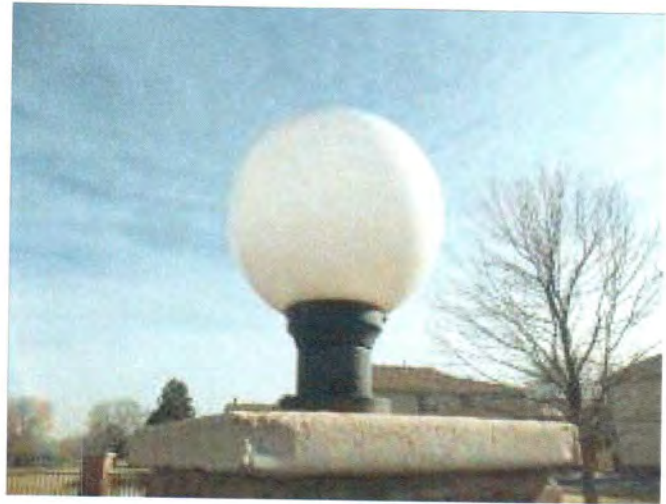
Comp #: 1607 Globe Lights - Replace

Due to the low quantity of globe light fixtures, we recommend replacing on an as needed basis using operating funds. No reserve funding necessary for these fixtures at this time.

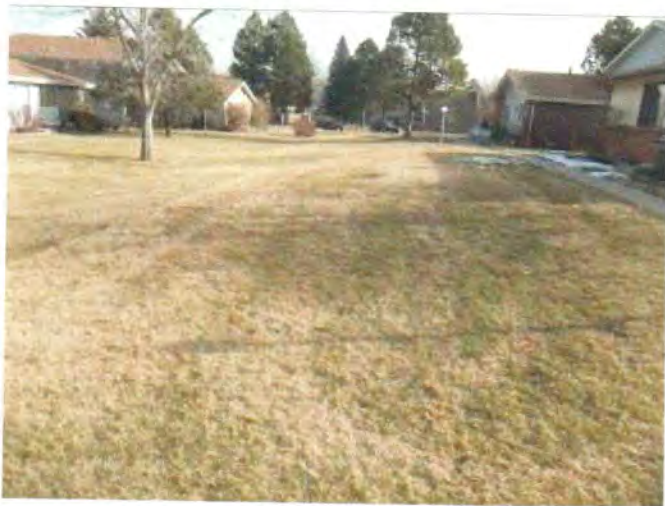
Comp #: 1701 Irrigation System - Major Repairs

At time of preparing this report, it was brought to our attention that some irregular turf areas are present on site. The landscape contractor recommended an allowance for major repairs that lie outside the scope of routine maintenance (rerouting lateral lines, bulk sprinkler head replacement, bulk valve replacement, rewiring, etc.). This line item is meant to ensure that the system continues to improve in terms of efficiency and water savings, as well as ensuring, generally, proper function. Expect to make major repairs to the system every 2 - 3 years. See component #1801 for more information regarding landscaping.

Allowance for major repairs

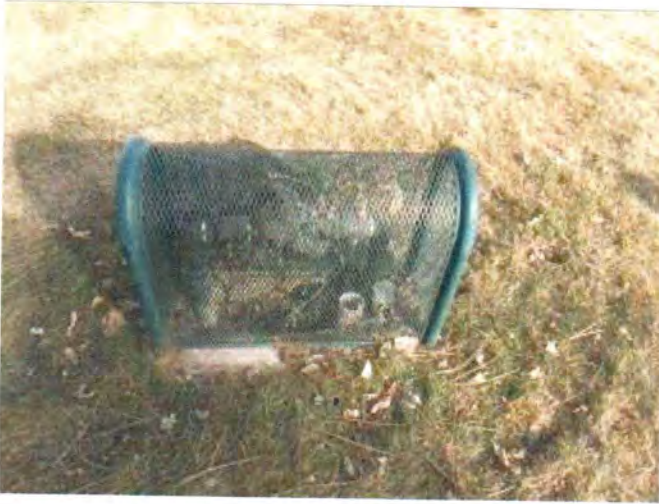
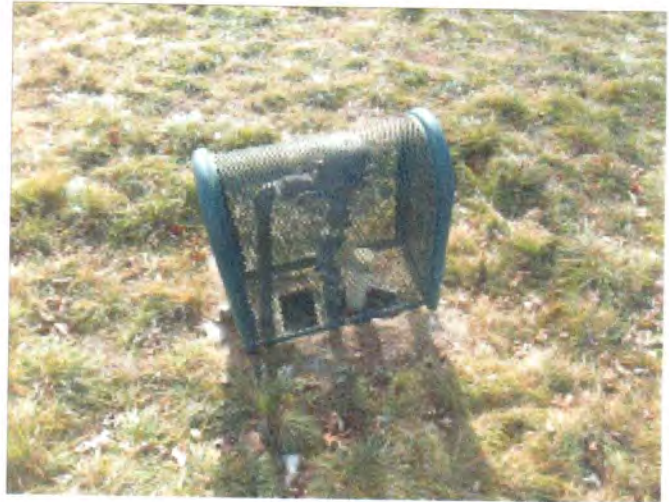
Comp #: 1706 Backflow Devices - Replace

No problems noted at the time of observation. Due to the minimal replacement cost (\$500 - \$800 each) and unpredictable useful life associated with this component, reserve funding is not appropriate. Make repairs and replacements as necessary as an operating expense.

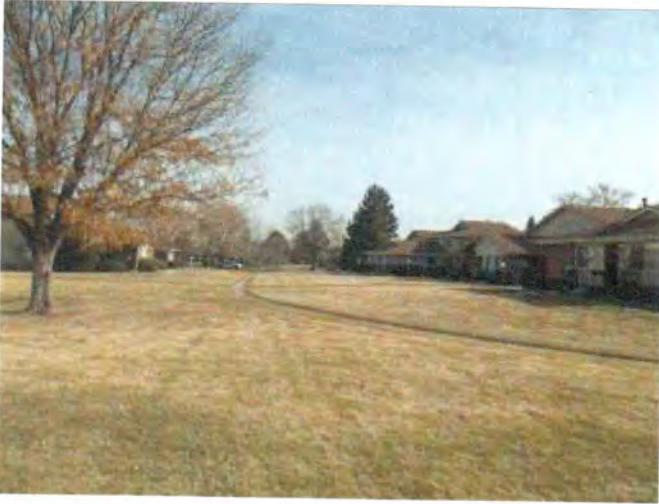
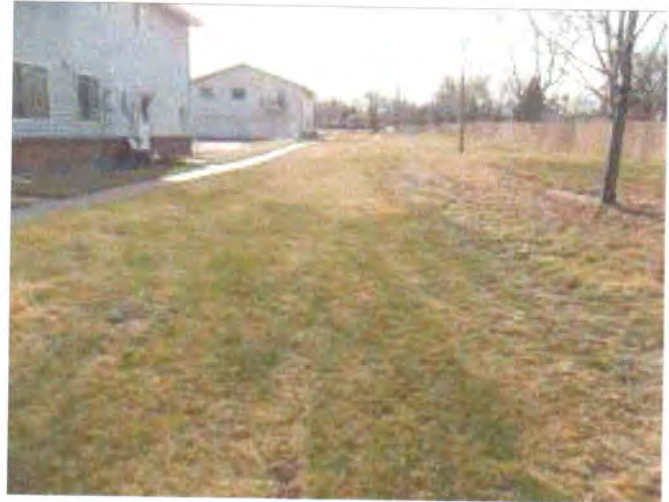
Comp #: 1801 Landscaping - Refurbish

Landscaping throughout the community is dated and in need of refurbishment within the next year (2015). It was reported that the association has performed landscaping and irrigation projects totaling approximately \$150,000 in the past 3 - 4 years. The areas that were affected include approximately 100,000 square feet of turf converted to native grasses and plants (naturalization project). It was recommended that other areas in the community should be refurbished and changed to bedded shrubs or other more modern and water efficient plants (in lieu of turf). Expect to make these refurbishments every 2 - 3 years. See component #1701 for more information regarding the irrigation system.
