Summary of Second Jefferson Green - Assoc. ID # - 07501-14

This report is an update to an existing Reserve Study that was prepared for the association 7 years ago for the 2007 fiscal period. An observation of the property's common area elements took place on December 13, 2013 to verify the information from this previous report. In addition, we obtained information by contacting local vendors and contractors, as well as communicating with the property representative. To the best of our knowledge, the conclusions and suggestions of this report are considered reliable and accurate insofar as the information obtained from these sources.

Funding Summary For Second Jefferson Green

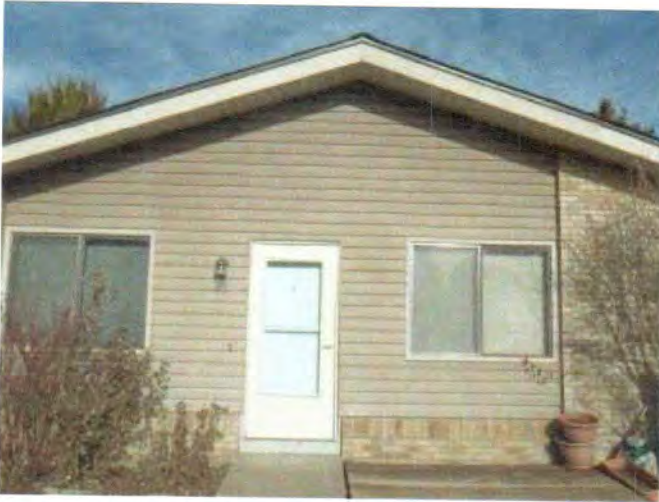
Comp #: 303 Vinyl Siding - Replace (2)

At time of observation it appeared that areas of vinyl siding are being replaced with new siding. The problem with the current process for vinyl siding replacement is that the colors do not match, the style is different and the overall appearance of the buildings is affected. The most apparent siding issues are on the South facing exterior walls where the siding has severely faded. The typical useful life of vinyl siding is 20 - 25 years in this environment and complete replacement should be planned within the next 9 - 11 years. We have split siding replacement into 3 phases in an attempt of ease budgeting concerns.

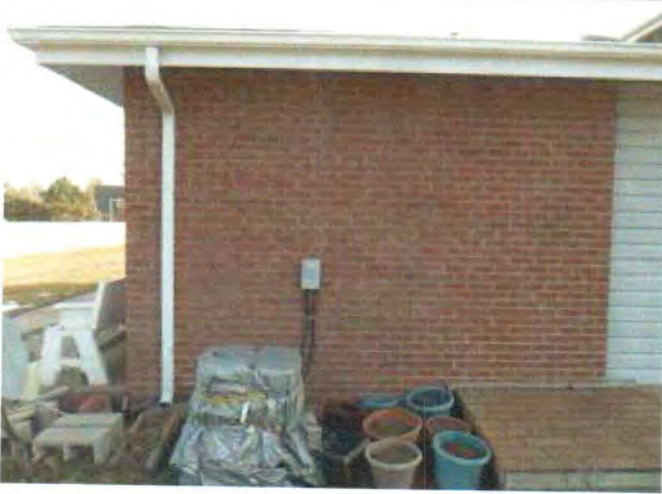
Comp #: 306 Brick/Flagstone - Replace

Stones and bricks appeared to be adhered to the sides well with no loose or missing material noted. Typically, this type of material has an extended life expectancy and complete replacement is unlikely. There are times where some stones will loosen and fall off, but this is unpredictable when and how much would occur. Repairs should be handled as a maintenance issue on an as needed basis. Therefore, Reserve funding is not required for this component at this time. If it later turns out that frequent repairs are necessary, then funding could be added in future Reserve Study updates.

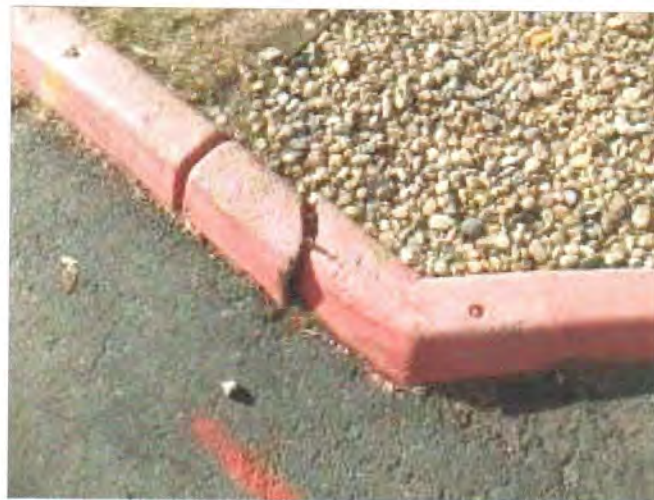
Comp #: 407 Drive Concrete - Replace

In general, concrete curbs and gutters are in poor condition with cracking and chipped surfaces throughout community. Many sections are either cracked or completely breaking apart. Curbs and gutters are subject to more advanced deterioration due to trucks and plows hitting them during the year. Since we are recommending that the association complete a full mill and overlay in approximately 3 years, we recommend replacing the curbing and drain pans at the same time in order to receive the best possible cost estimate based on quantity of work. If the work is completed upon updating this report, we can adjust this line item to reflect a periodical allowance in the future for concrete repairs rather than complete replacement.

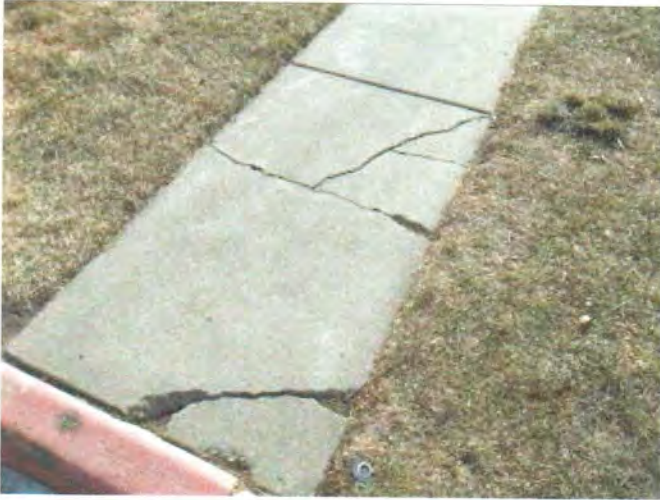
Comp #: 601 Concrete Sidewalks/Decks - Repair

It is unlikely that all concrete surfaces will fail and need to be replaced at the same time. Based on our recent property observation, the sidewalk concrete conditions are worsening and therefore we are recommending a more aggressive plan for repairs/replacement. Frequent repairs and replacement to a percentage of the area (10% or 4200 GSF), should be anticipated every 4 years.

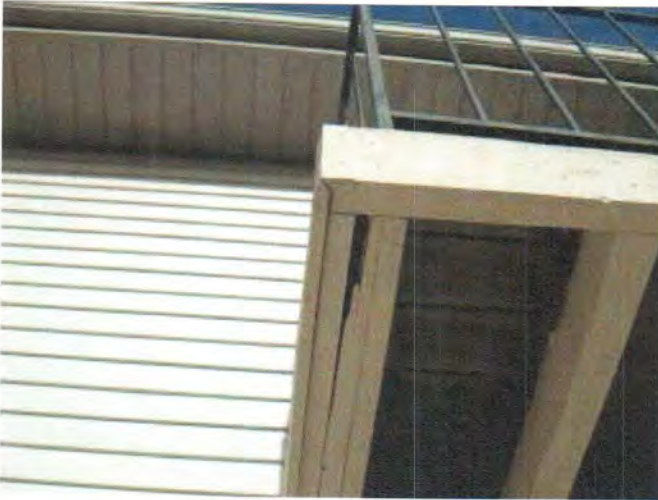
Comp #: 607 Wood Deck - Replace

Some units had front decks, but they varied in design, size, and type of material from unit to unit. Assume these front decks are the responsibility of the individual unit owner. Therefore, Reserve funding is not required for the front decks. The upper unit decks are considered to be exclusive use common areas and should be the responsibility of the owner that has access to the decks. However, it was reported the decks are the responsibility of the association. Due to varying conditions and levels of use, we recommend replacing approximately 10 decks every 4 years. When replacement is required, we recommend using an alternative product (composite decking) that has a longer life expectancy and requires less maintenance.

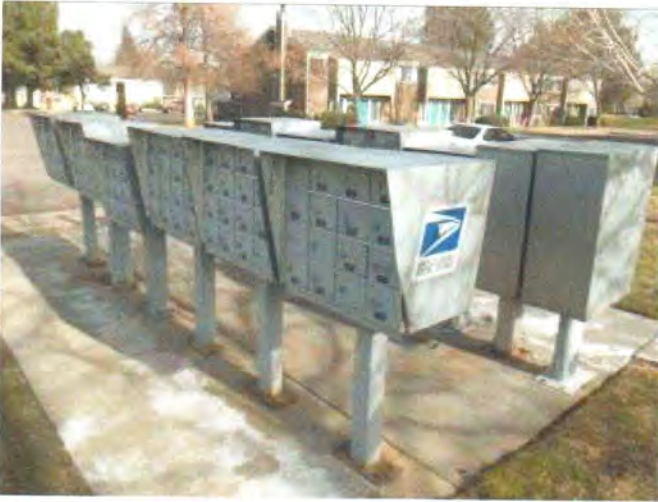
Comp #: 803 Mailboxes - Replace

Mailbox stations are rusting at the base where they are anchored into the concrete pad. According to several manufacturers, the typical life expectancy for this type of mailbox is 12 - 18 years in this environment. Remaining life is based on average age of all units. While it is possible the US Post Office will maintain and replace these boxes in the future, in our experience, we have seen in numerous similar circumstances that the post office makes the association responsible for replacement. This line item is included as a conservative measure in case the post office decides the association is responsible for replacement.

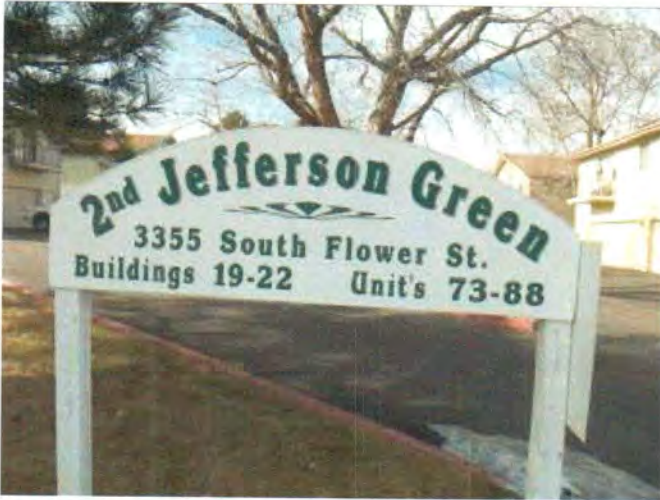
Comp #: 809 Address Signs - Replace

Noted several areas of missing paint and some of the plywood chipping off on at least one sign. Another sign had been vandalized. It is typical for similar communities in the area to replace address signs every 10 - 12 years in order to ensure legibility and a modern and appropriate appearance to the community entrances. Expect to replace these signs during this fiscal year (2012) to restore/modernize the appearance.

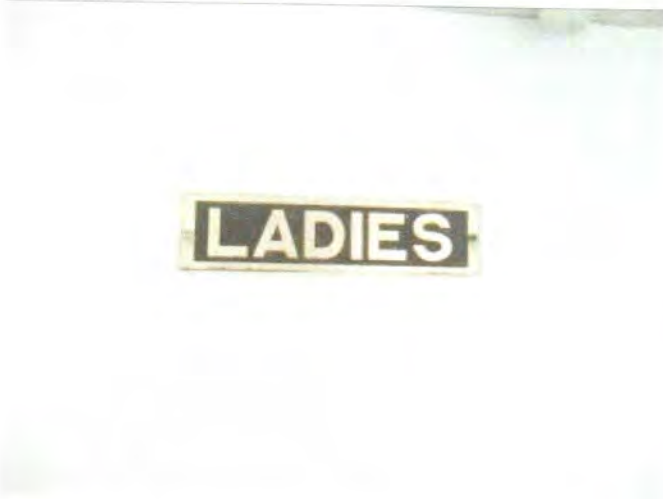
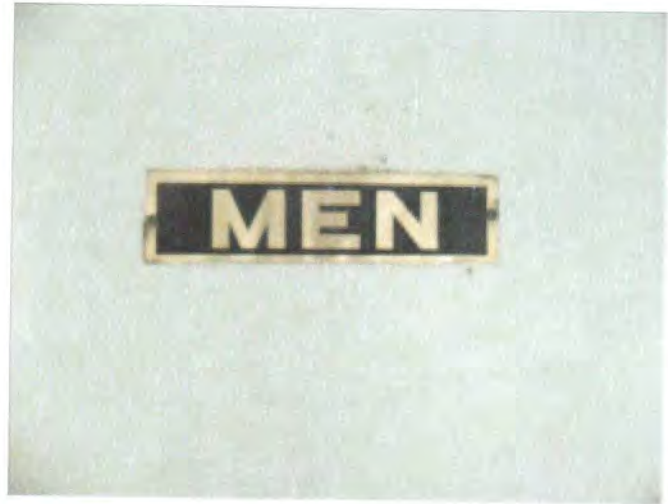
Comp #: 1413 Restroom - Remodel

We were unable to access the restrooms at time of site observation. However, no reports of remodeling or reports of problems were brought to our attention at time of preparing this report. Expect to remodel pool restrooms every 15 - 20 years if properly maintained.

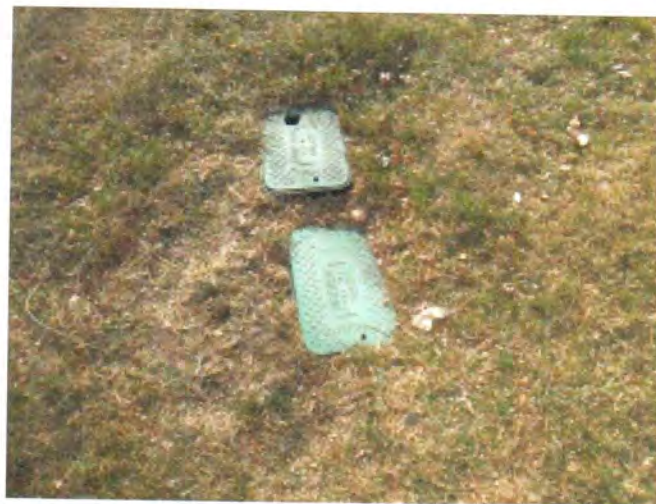
Comp #: 1701 Irrigation System - Major Repairs

At time of preparing this report, it was brought to our attention that some irregular turf areas are present on site. The landscape contractor recommended an allowance for major repairs that lie outside the scope of routine maintenance (rerouting lateral lines, bulk sprinkler head replacement, bulk valve replacement, rewiring, etc.). This line item is meant to ensure that the system continues to improve in terms of efficiency and water savings, as well as ensuring, generally, proper function. Expect to make major repairs to the system every 2 - 3 years. See component #1801 for more information regarding landscaping.
